HILTI ANCHOR BOLT FIXING AT BLAST FURNACE REVAMPING

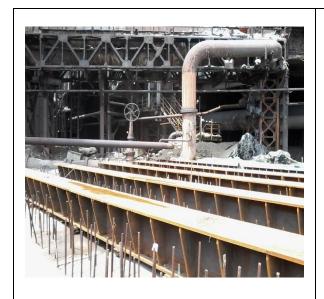
Before After

Pulling the hook break from the base of the concrete due to a hydraulic jerk at the time of pull-out during the blast furnace foundation.
