CONSTRUCTION OF COMPOUND WALL AT KUNAL ICON HOUSING SOCIETY

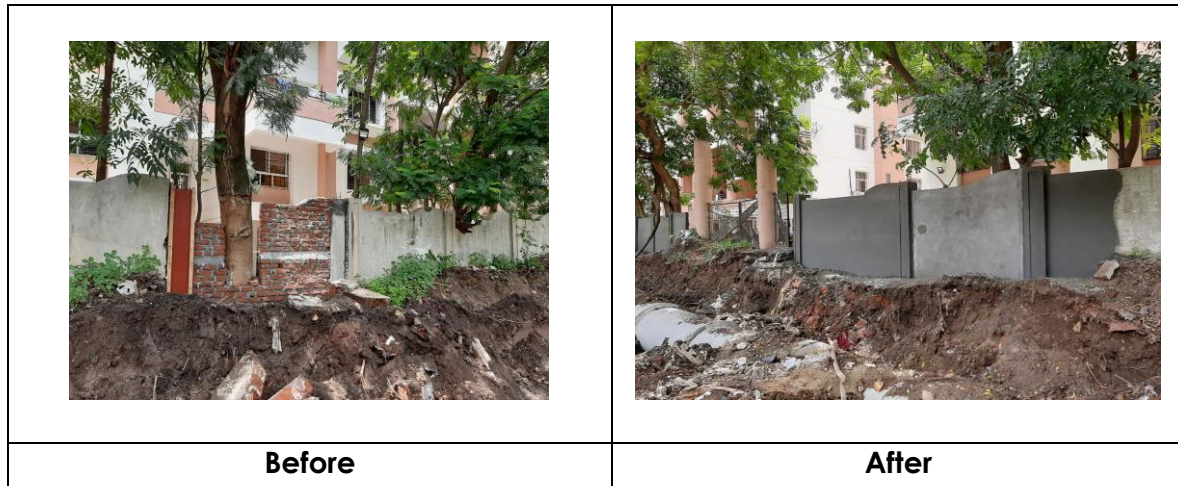
- There were major cracks in the compound wall and the corporation had sent a notice to the society to repair the wall immediately.
- Many big trees had caused damage to the brick wall and it wasn't possible to cut the trees.

- We constructed a brick wall and maintained some gap between the tree and the wall.
- We prepared a ferrous cement thin wall to maintain the external aesthetic view and to maintain the gap between the walls.
