COLUMN STRENGTHENING AT MERCK'S BIOLOGICAL PARK

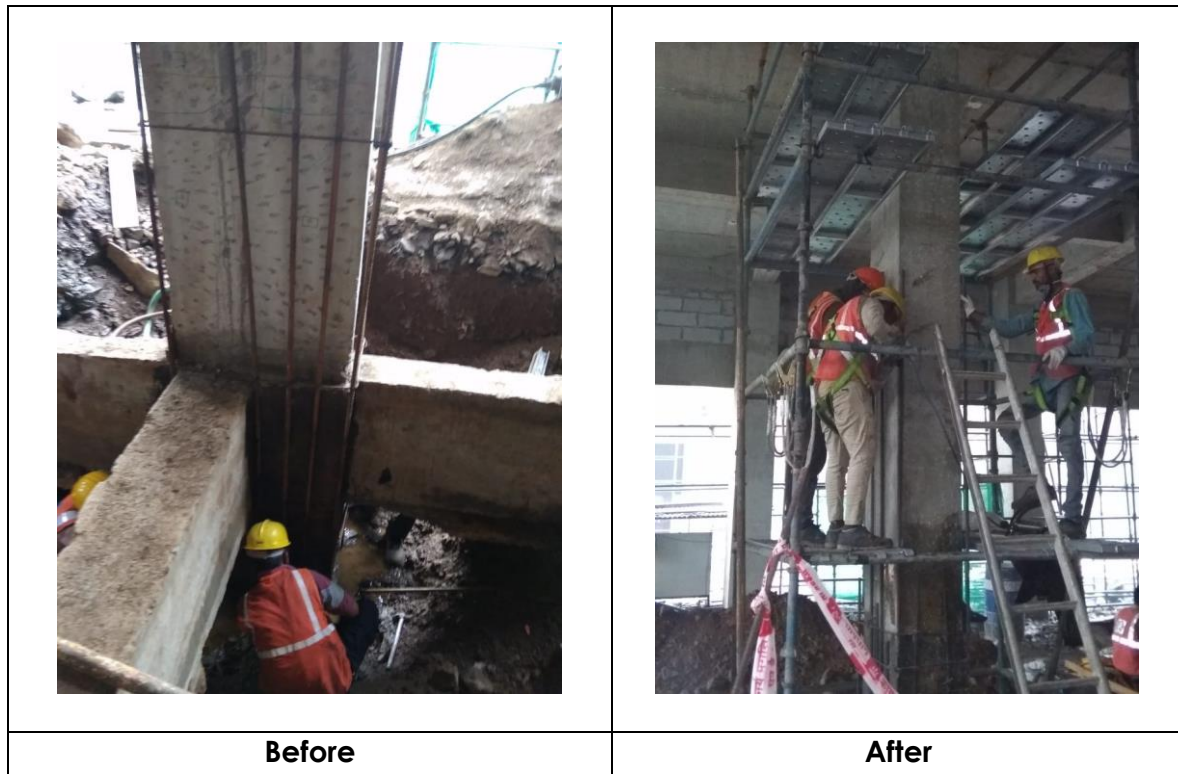
- The RCC column got damaged due to an accident at the time of structural erection.

- We strengthened the existing columns and sealed the micro-cracks using MONOMER (MONOPOL) low.
- Provided additional reinforcement with shear connectors.
- Casted micro concrete to achieve high early strength.
- Work was carried out and completed as per client's erection schedule.
