## CRUSHER FOUNDATION STRENGTHENING BY STEEL JACKETING AT COKE OVEN

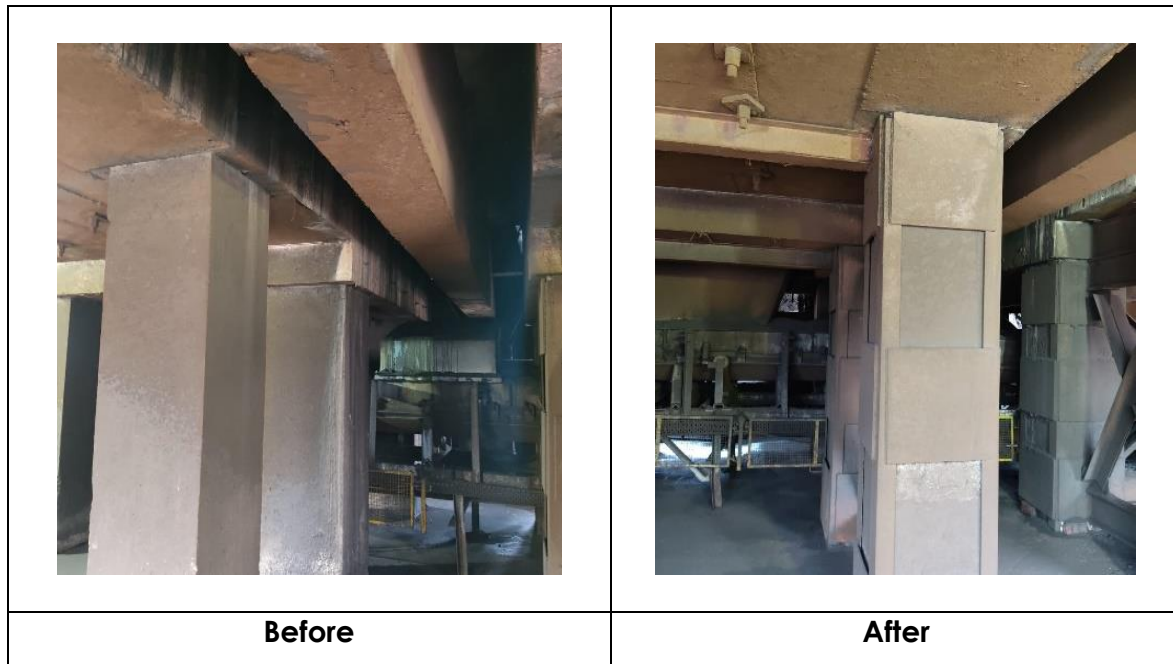
- The columns and slabs of the crusher foundation had heavy vibrations due to load.

- We provided Steel plate jacketing to the crusher column.
- Provided low viscous pressure epoxy grouting into the gap of the existing column and plates.
- The entire job was completed within 10 days and the structure has been used successfully from the last 7 years effectively.
