## CEMENT GROUTING OF RCC WALL AT RAW WATER RESERVOIR

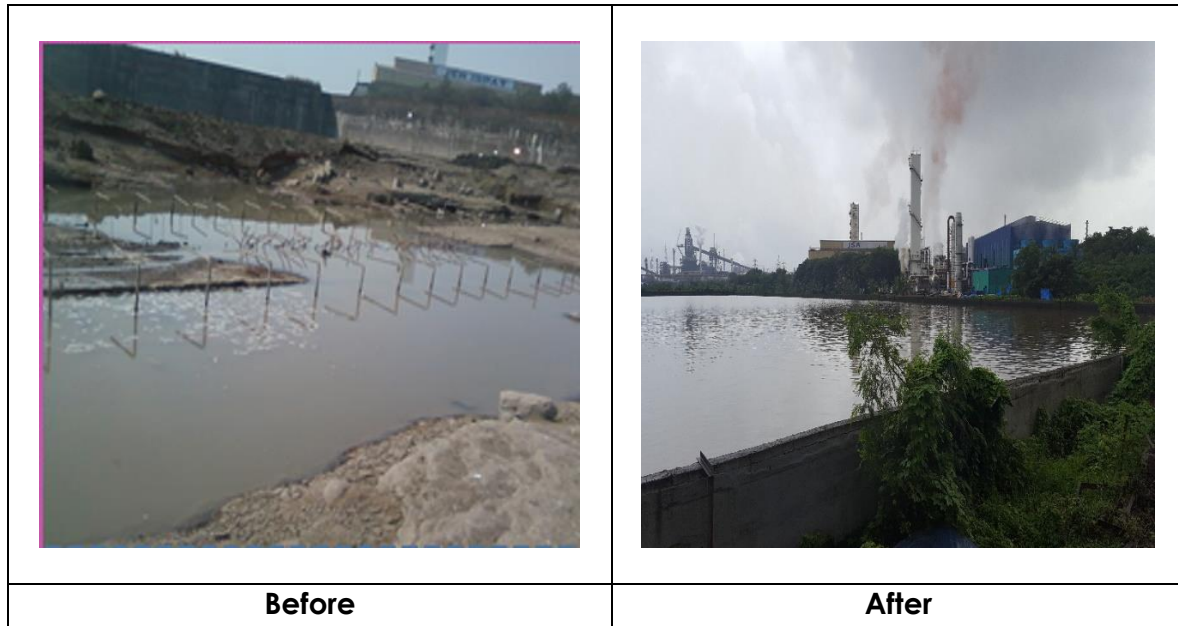
- Water leakages from the RCC wall construction joints and the honeycomb area.
- The Ground water table was high

- Provided treatment to the construction joint.
- We fixed the nozzle in a staggered position.
- Provided grout cement slurry with pressure grouting to stop the leakages.
