## PWD ROAD MAJOR BRIDGE CORROSION DAMAGE AT KOLHAPUR

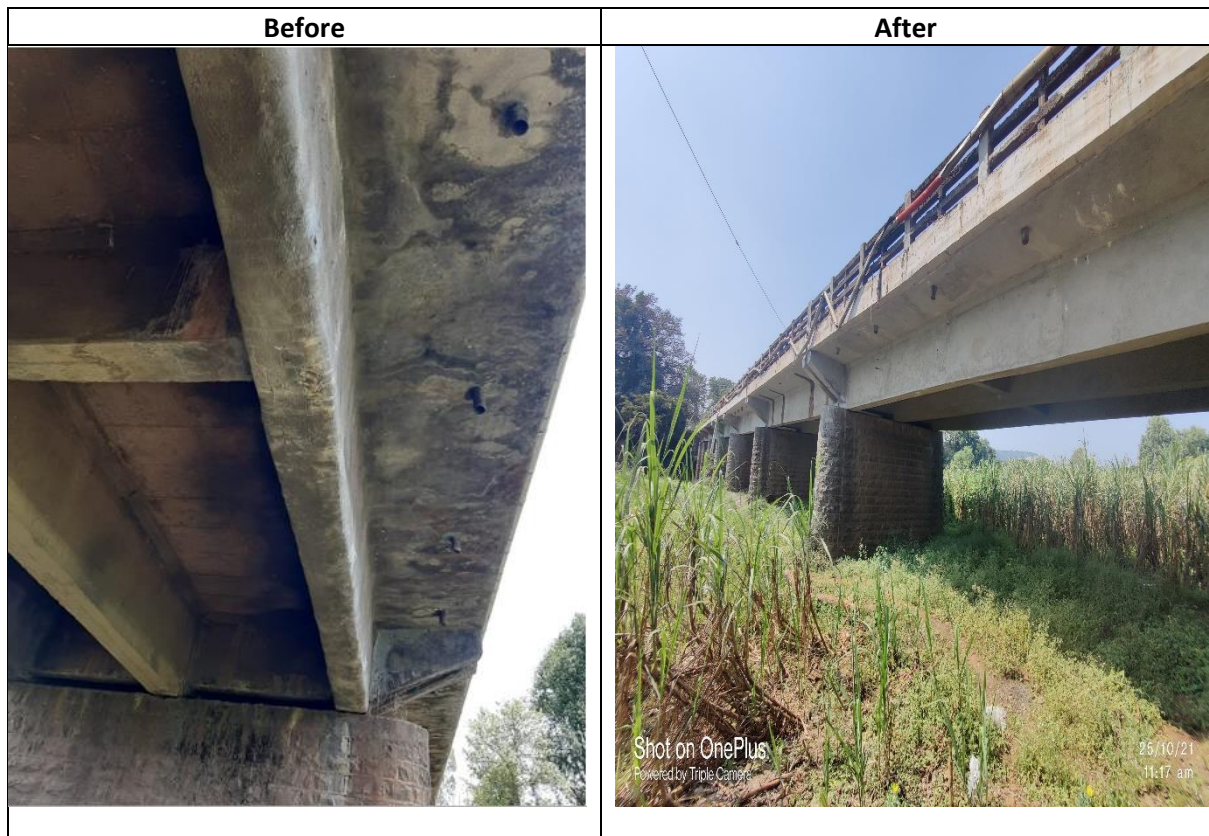
- River Bridge 45 Years old.
- Major corrosion damage.
- Honeycomb of the Concrete girder.
- Previously repair by guniting but this repair not bonding to the concrete & shown crack.

- Prepare safe access hanging platform.
- Remove guniting & loose cover concrete.
- Anticorrosive treatment with corrosion inhibitor.
- Apply additional reinforcement with shear keys.
- Apply epoxy bonding agent.
- Repair concrete girder with PMM.
- Repair External beam with micro concrete.
