CORE CUTTING AND FOUNDATION BOLT GROUTING OF RAIL TRACK AT PELLET PLANT

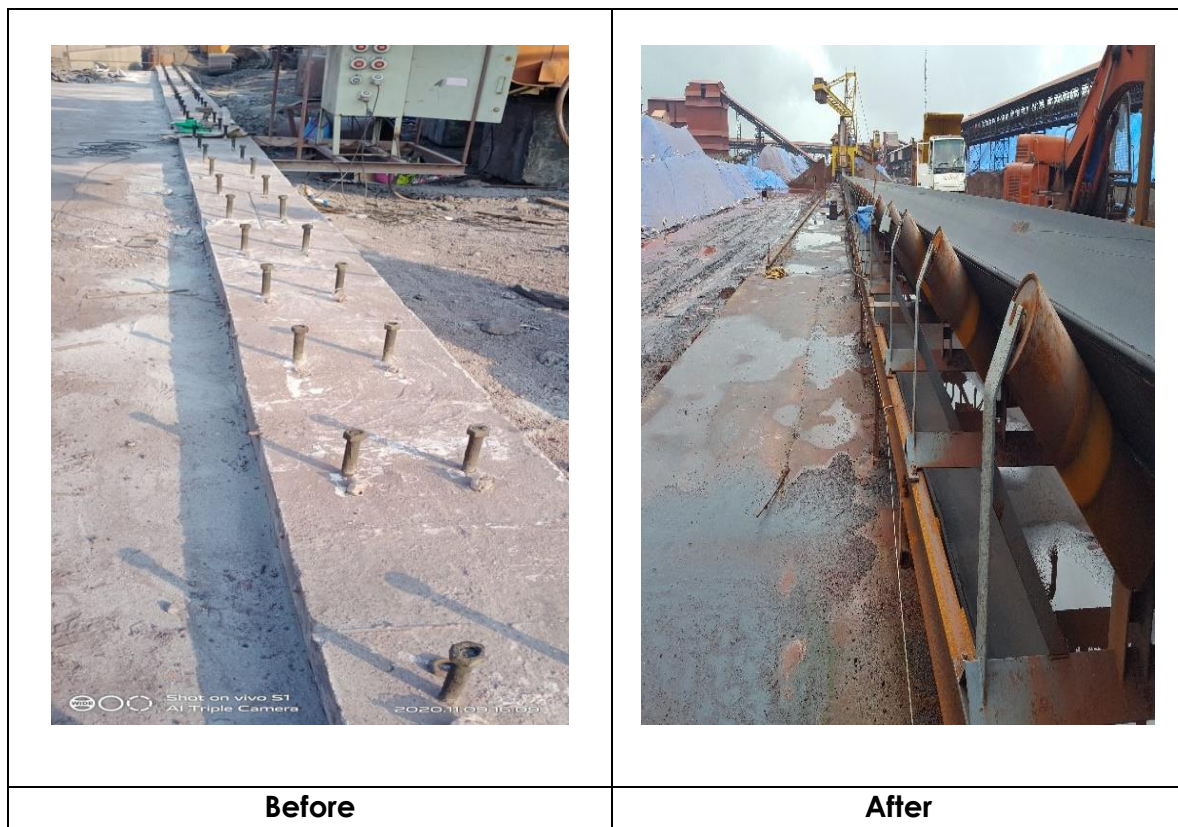
- The Rail track foundation shifted upto 50 mm (80 % of the track) except the starting and ending location due to the land settlement below.

- After the original observation of the track, we suggested additional new anchor bolts as per the original rail track alignment.
- Core cutting: 28 MM dia hole was provided
- Provided M:24X50 dia Hilti Anchor bolt grout with RE-500.
- We completed the entire anchoring job within a month.
