LOCO RAIL TRACK FOUNDATION BOLT REPLACE AT COKE OVEN PLANT

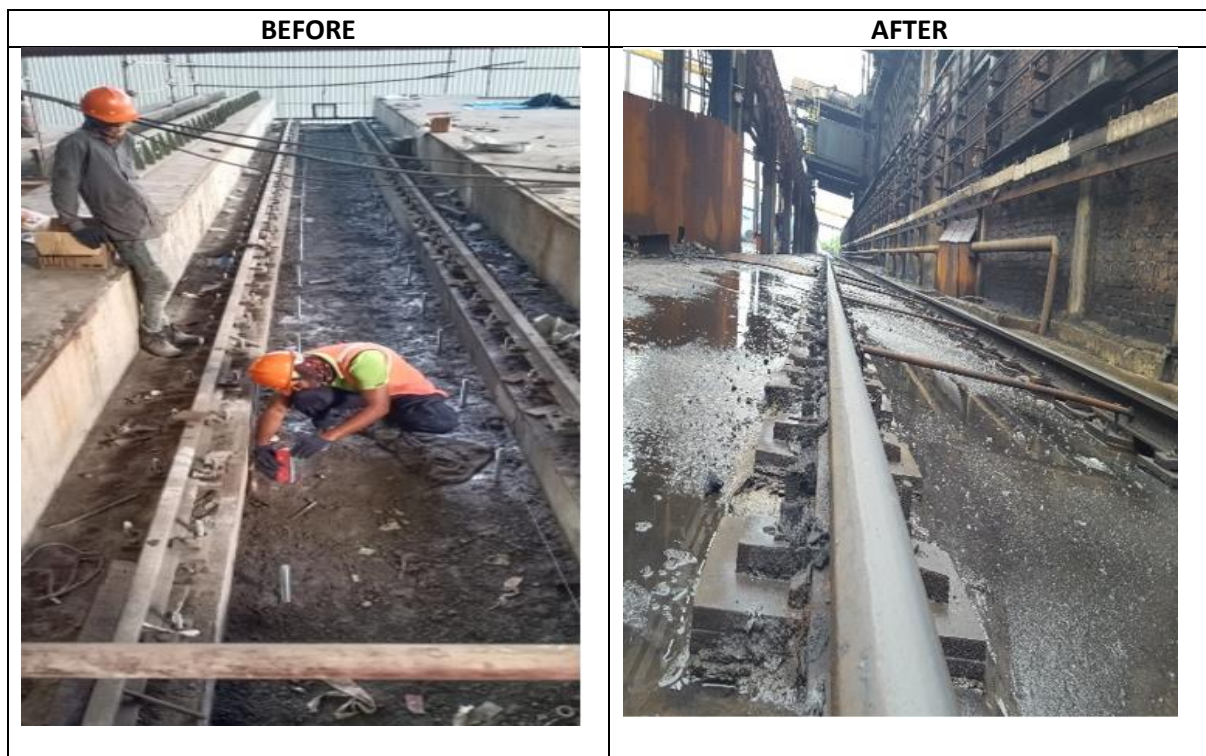
- Bolts of rail tracks breaking due to heavy load of raw material carrying loaded wagons.
- Acidic and hot water reactions with existing bolt
- Difficult to replace the bolts due to continuous work and running of rail

- We used core cutting technique due to heavy reinforcements in the foundation.
- We are working here at the limited shut down time of 90 minutes without disturbing the daily work.
