STRUCTURAL CONCRETE CRACK REPAIRS AT HADAPSAR BRIDGE

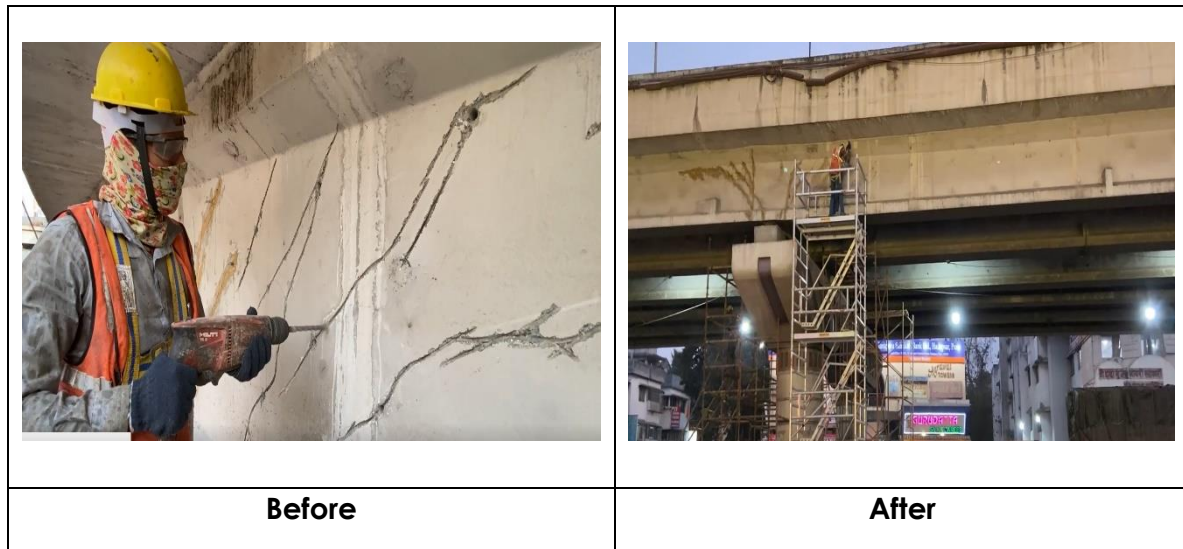
- Cracks with the potential to become a significant structural problem occurred in the support piers of a motorway bridge due to excessive dynamic loads from increased traffic.

- Opening of Crack in V Shape cracks > 0.3 mm.
- Drilling of Holes in 300mm c/c distance in perpendicular to crack opening and after that dust remove from hole with help of blower.
- After dust remove, we fixed nozzle in hole.
- Primer application on crack opening after nozzle fixing.
- After Primer Application seal the crack with help of mortar.
- After sealing the Crack Grouting with low viscosity epoxy resin based on fosroc with help of pump.
